RSBG-6 & RSBG-8 SAFETY NOTICE

It has come to our attention that the initial batches of our new grinders have a non-conforming work rest, which does not allow for correct or compliant adjustment at all angles.

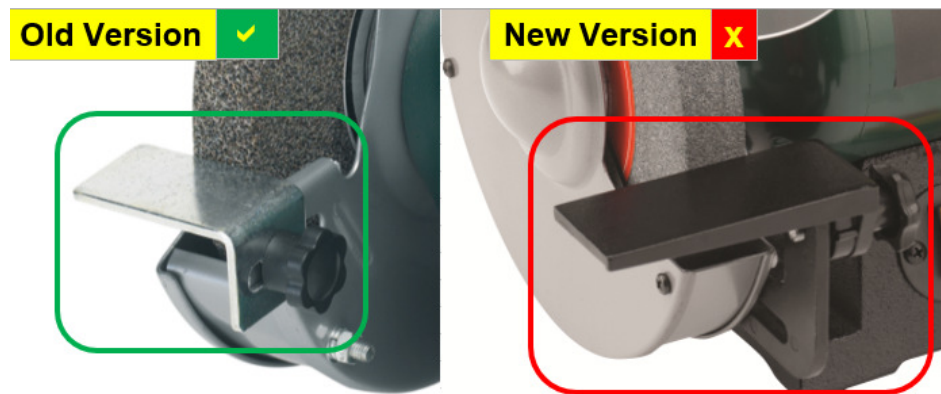
If the work rest of your bench grinder looks like the “**Old Version**”, your machine **IS NOT** affected!
If it looks like the “**New Version**”, your machine **IS** affected!

We have found that the bracket on our first batches of machines allows for this at 90°, but not when the work rest is tilted at certain angles.

The reason this is a safety issue and the standard recommend 2mm maximum is to reduce any risk of a workpiece being snatched downwards by the stone, trapped between the work rest and the stone and potentially causing the stone to fracture at speed, which could cause serious injury.

We are currently making new brackets to resolve this issue, which will require the simple addition of a spacer, washer and the new wing screw with correct dimensions. We expect the first batches of replacement parts to be available from 12 November 2018.

- 5mm spacer
- 3mm washer
- 16mm wing screw
